18. SUPPLEMENTARY NOTES		
19. KEY WORDS (Continue on reverse side if necessary and identify by block number) Dams Dam Safety National Dam Safety Program Akers Dam, TN Turners Station, TN Sumner County, TN. Embankments Visual Inspection Structural Analysis

PHASE I INSPECTION REPORT
NATIONAL DAM SAFETY PROGRAM

Name of Dam Akers
County Sumner
Stream Unnamed Trib. of
Little Trammel Creek
Date of Inspection April 15, 1981

Akers Dam, Sumner County, Tennessee

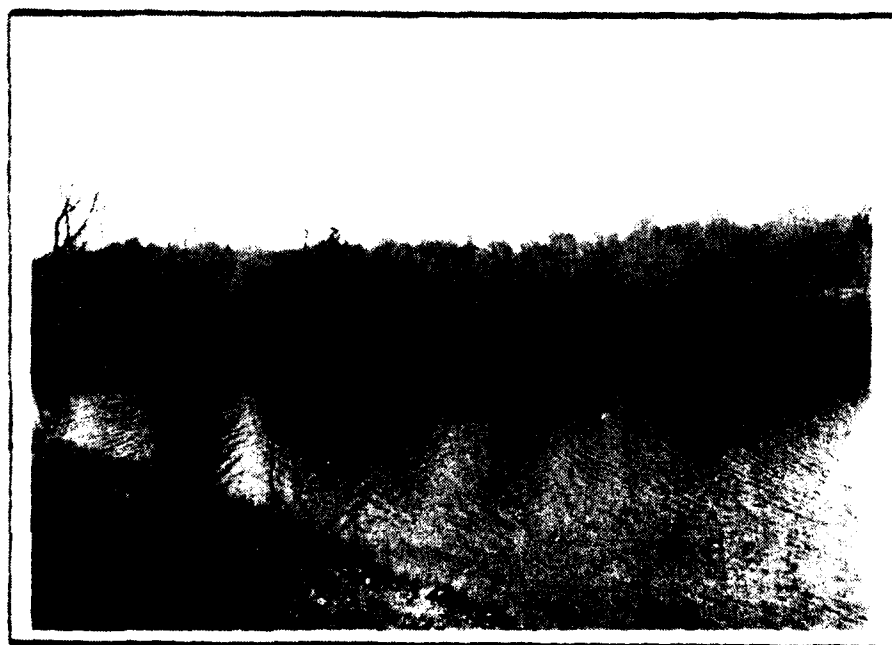
PHOTO NO.2

3.1.1 Embankment - The entire upstream face is covered with moderately heavy brush and small diameter deciduous trees (photo no. 2). Some trees, mainly sycamore, have diameters up to 6 inches. There was no designed slope protection with only intermittent rock along the waterline. A small berch has formed below the waterline from the slight erosion of the upstream face. No signs of structural instability were found along the upstream face.

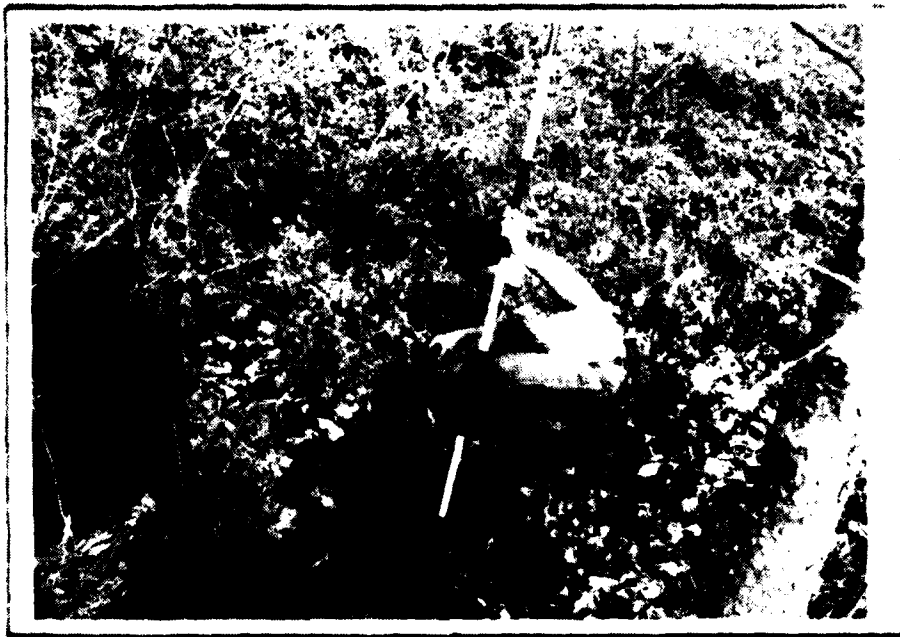
PHOTO NO.7

2.4.3 Drawdown Facility - Drawdown capability is provided by a 6-inch cast iron pipe with a manually operated gate valve on the downstream end of the pipe. The valve is located at the toe near the right abutment (Figure 3 and photo 7).

3.1.3 Drawdown Facility - The gate valve on the downstream end of the pipe is the portion of the facility that could be seen. The outlet could not be located. A portion of the pipe revealed by hand digging appeared in good condition. The wheel for the valve had been removed and the caretaker was not certain of its location. The valve apparently has not been operated since construction.

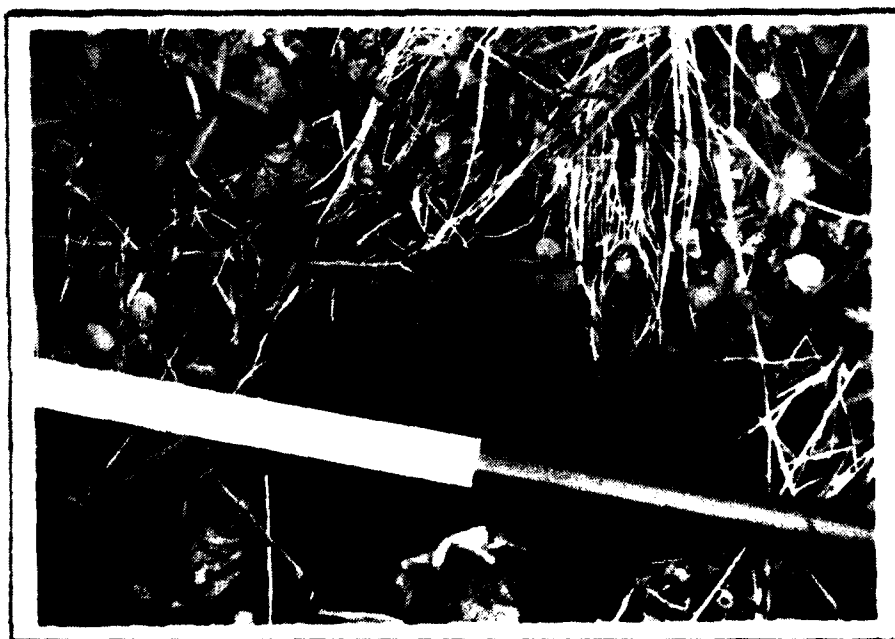
PHOTO NO.16

The downstream face has some briers, brush, and small trees but is mainly covered with deciduous trees between 2 and 8 inches in diameter (photo no. 3). No erosion of the downstream face was noted. The downstream slope flattened to a variable slope roughly halfway down the face. A large area of saturation was found along the left half of the dam and generally started at the change in slope and extended to the toe (photo nos. 11 and 12). Shallow, spotty sloughing was noted in the saturated area (photo nos. 9 and 10). A flow of 1 gpm was found roughly 30 feet from the left abutment and about 10 feet below the crest. The flow appeared clear but residual gravels from the embankment material were observed at the opening (photo nos. 13 and 14). Total flow from the saturated area was estimated to be 4 gpm (photo no. 17). Another small flow was found about 5 feet upstream from the drain valve. Flow was clear and less than $\frac{1}{2}$ gpm (photo nos. 15 and 16). A

- Photo No. 16 - Close up of small flow
- Photo No. 17 - Cumulative flow from seepage area.
- Photo No. 18 - Stream channel from culvert at Old Hwy 31.
